**No. 96**      **Double Hull Oil Tankers - Guidelines for Surveys,**  
(April      **Assessment and Repair of Hull Structures**  
2007)

## DOUBLE HULL OIL TANKERS

Guidelines for Surveys, Assessment and Repair  
of Hull Structures

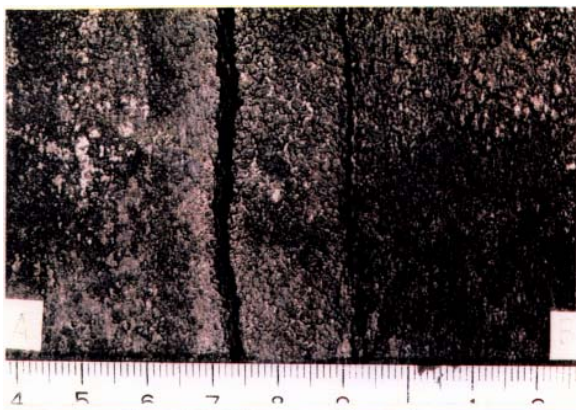
**4.1.3** Bottom or “docking” plugs should be carefully examined for excessive corrosion along the edge of the weld connecting the plug to the bottom plating

**Photograph 1**  
**Grooving corrosion of welding of bottom plating**

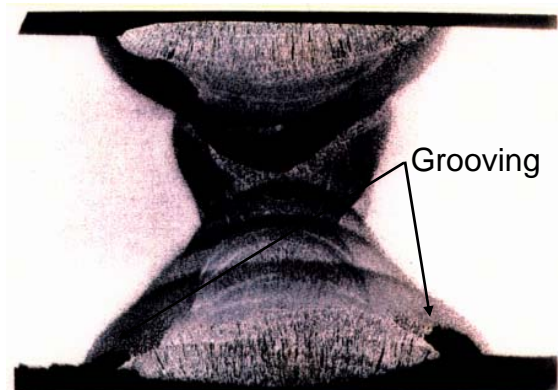
**Photograph 2**  
**Section of the grooving shown in Photograph 1**

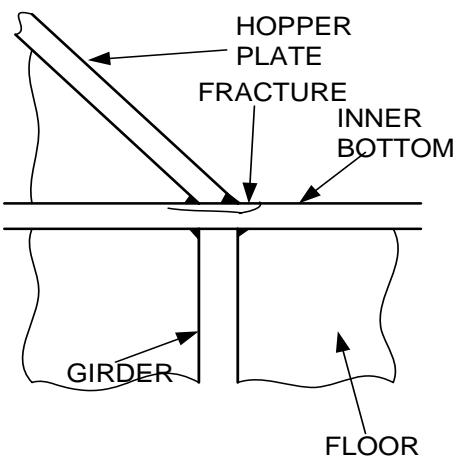
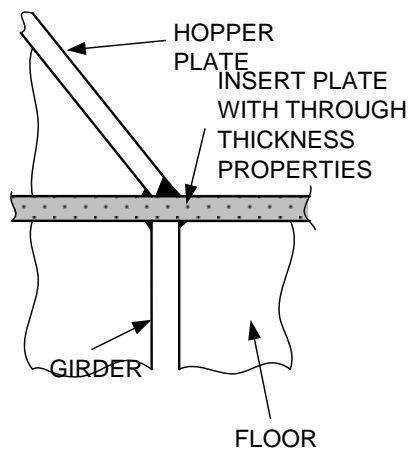
OIL Tankers		Guidelines for Surveys, Assessment and Repair of Hull Structure	
Group 1	Cargo area	Example No.	
	Hopper and double bottom ballast tank	2	
Detail of damage		Fracture at connection of bilge hopper plate and inner bottom	
<p><b>Sketch of damage</b></p>

<p><b>Notes:</b> Plate midlines intersect</p>	
<p><b>Factors which may have caused damage</b></p> <p>1. Stress concentration at the knuckle.</p>		<p><b>Notes on repairs</b></p> <p>See Sketch.</p>

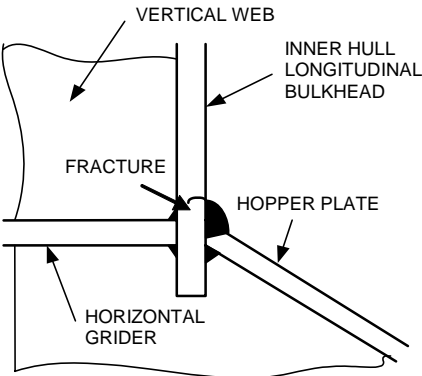
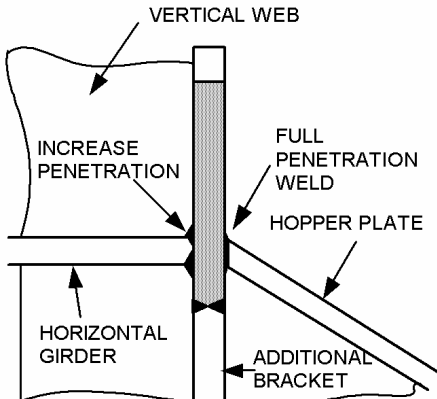
OIL Tankers		Guidelines for Surveys, Assessment and Repair of Hull Structure	
Group 1	Cargo area	Example No.	
	Wing cargo tank	8	
<b>Detail of damage</b>		Fracture at the connection of hopper plate to outside longitudinal bulkhead.	
<b>Sketch of damage</b>		<b>Sketch of repair</b>

<b>Factors which may have caused damage</b>		<b>Notes on repairs</b>	
<ol style="list-style-type: none"> <li>1. Stress concentration at junction of hopper plate to outside longitudinal bulkhead.</li> <li>2. Insufficient welding connection and/or incorrect shape of the weld toe.</li> <li>3. Misalignment between hopper plate, outside longitudinal bulkhead and side stringer.</li> </ol>		<p>See Sketch.</p>

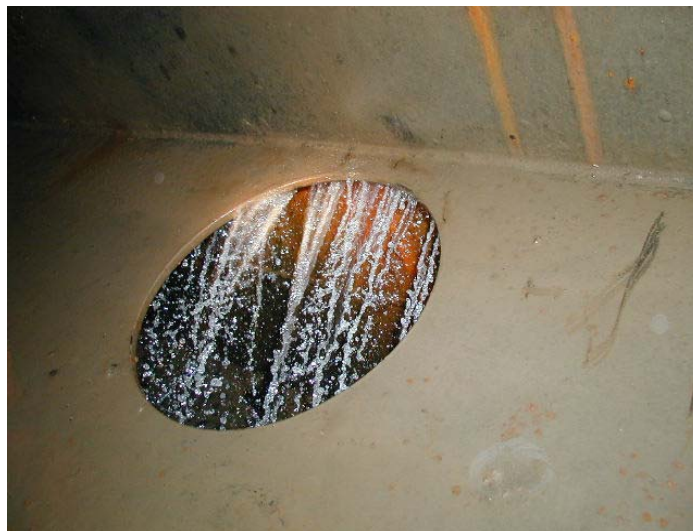
**Photograph 1 Side shell fracture in way of horizontal stringer weld**

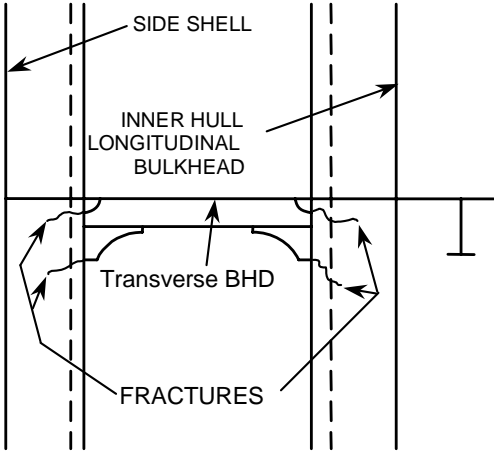
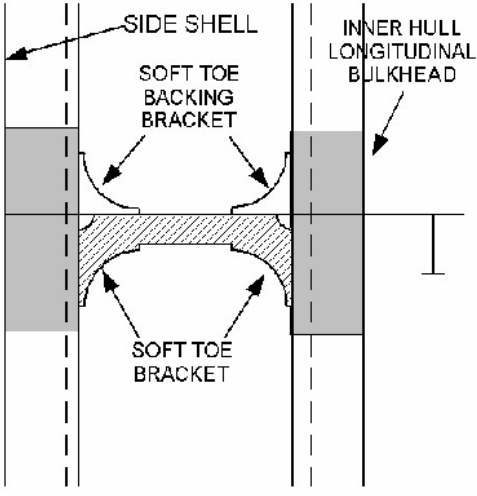
OIL Tankers		Guidelines for Surveys, Assessment and Repair of Hull Structure	
Group 2	Cargo area	Example No.	
	Wing ballast tank	1	
<b>Detail of damage</b>		Crack in way of connection of longitudinals to transverse bulkhead	
<b>Sketch of damage</b>		<b>Sketch of repair</b>

<b>Factors which may have caused damage</b>		<b>Notes on repairs</b>	
<ol style="list-style-type: none"> <li>1. Asymmetrical connection of bracket without backing bracket.</li> <li>2. Relative deflection of adjoining transverse web against transverse bulkhead.</li> <li>3. Additional biaxial bending stresses due to asymmetry of the angle bar longitudinal instead of symmetric T section.</li> <li>4. Dynamic load in the vicinity of the water line.</li> <li>5. Large upstand at bracket toe.</li> </ol>		<p>See Sketch.</p>

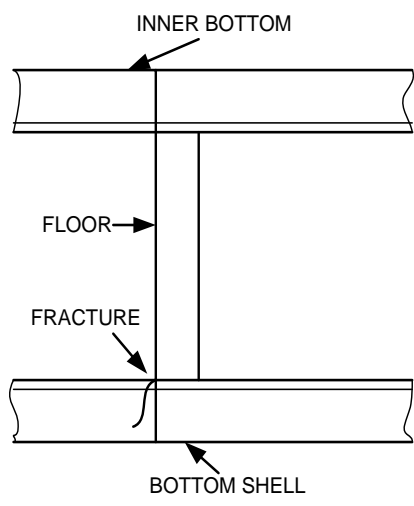
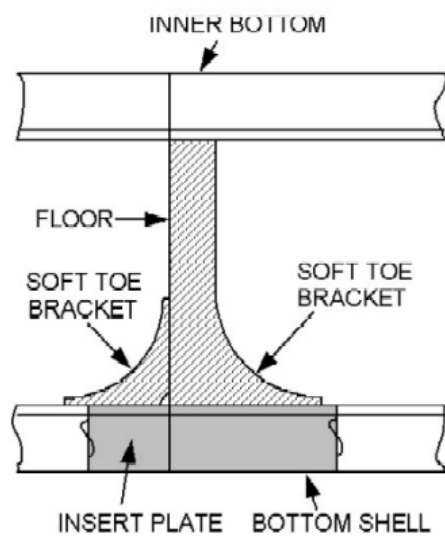
<b>OIL Tankers</b>		<b>Guidelines for Surveys, Assessment and Repair of Hull Structure</b>	
<b>Group 3</b>	<b>Cargo area</b>		<b>Example No.</b>
	<b>Bottom ballast tank</b>		<b>4</b>
<b>Detail of damage</b>		Connection of longitudinals to ordinary floors	
<p><b>Sketch of damage</b></p>

<p><b>Factors which may have caused damage</b></p> <ol style="list-style-type: none"> <li>1. Stress concentration at the connection of bottom longitudinal and stiffener on floor.</li> </ol>		<p><b>Notes on repairs</b></p> <p>See Sketch.</p> <ol style="list-style-type: none"> <li>1. Butt welds in bottom longitudinal should be kept clear of the soft toe bracket toes.</li> <li>2. If possible soft toe bracket and vertical stiffener should be integral.</li> </ol>

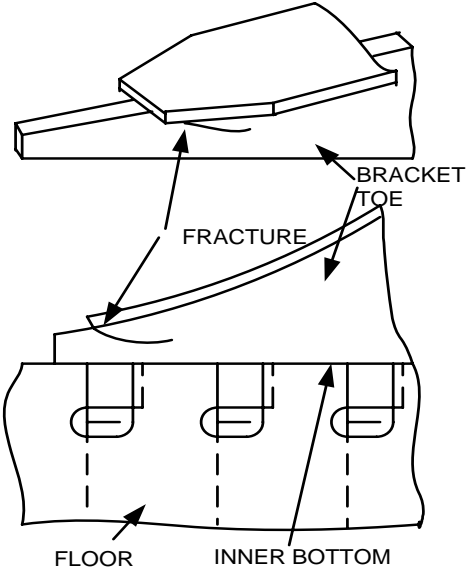
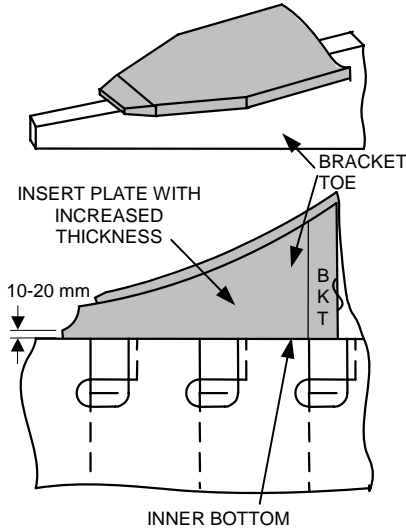
OIL Tankers	Guidelines for Surveys, Assessment and Repair of Hull Structure	
<b>Group 4</b>	<b>Cargo area</b>	<b>Example No.</b>
	<b>Web Frame in cargo tank</b>	<b>1</b>
<b>Detail of damage</b>	Fracture at toe of web frame bracket connection to inner bottom.	
<b>Sketch of damage</b>	<div style="display: flex; justify-content: space-between;"> <div style="width: 45%;">

</div> </div>	
<b>Factors which may have caused damage</b>	<p>1. Inadequate tapering the toe end.                  2. Insufficient tapering of flange.                  3. Lateral flexing of the bracket.</p>	
	<b>Notes on repairs</b>	See Sketch.

</div> <div style="width: 45%;"> <p><b>Sketch of repair</b> Modify Face Taper</p> <ol style="list-style-type: none"> <li>1. Breadth taper 20 degrees.</li> <li>2. Breadth at toe as small as practical.</li> <li>3. Thickness taper 1 in 3 to 10mm.</li> </ol>

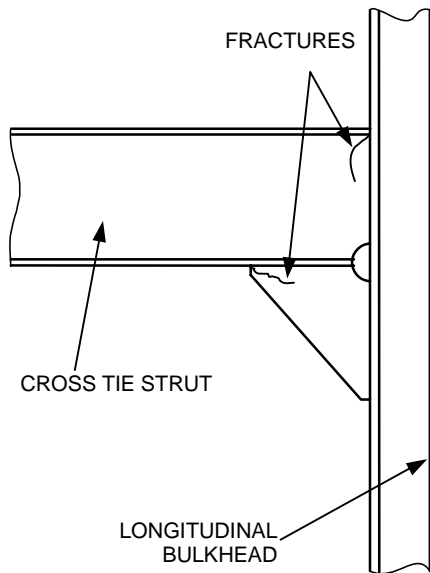
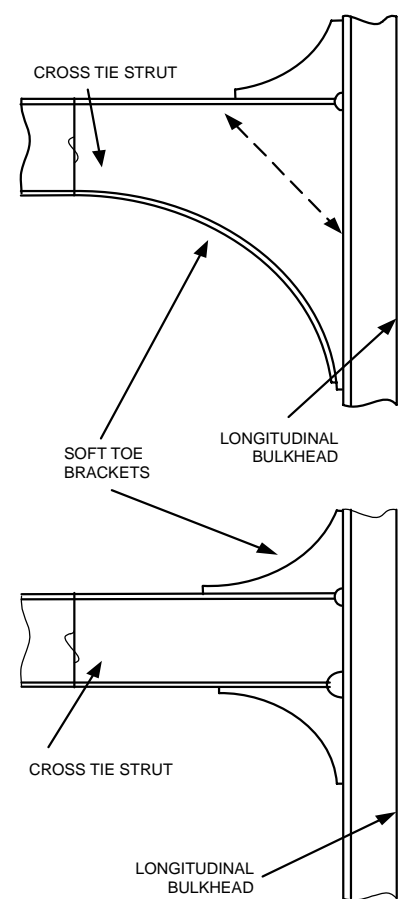
<b>OIL Tankers</b>		<b>Guidelines for Surveys, Assessment and Repair of Hull Structure</b>	
<b>Group 4</b>	<b>Cargo area</b>	<b>Example No.</b>	
	<b>Web Frame in cargo tank</b>	<b>2</b>	
<b>Detail of damage</b>		<b>Cross ties and their end connections</b>	
<b>Sketch of damage</b>		<b>Sketch of repair</b>

<p>The sketch shows two views of the repair. The top view shows a 'CROSS TIE STRUT' connected to a 'LONGITUDINAL BULKHEAD' using 'SOFT TOE BRACKETS'. The bottom view shows another 'CROSS TIE STRUT' connected to the 'LONGITUDINAL BULKHEAD'.</p>	
<b>Factors which may have caused damage</b>		<b>Notes on repairs</b>	
<ol style="list-style-type: none"> <li>1. Stress concentration due to unsuitable bracket shape at juncture of cross tie to longitudinal.</li> <li>2. Inadequate panel stiffening of web plate of cross-tie.</li> </ol>		<p>See Sketch.</p>

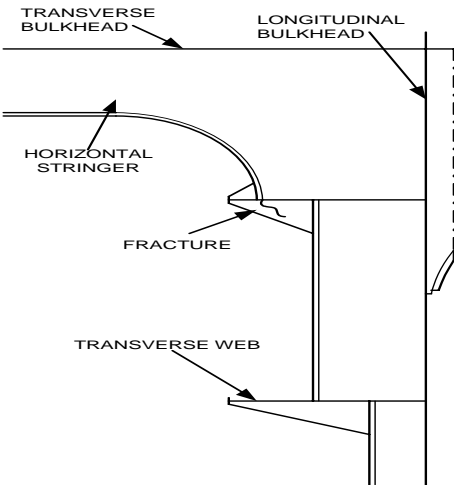
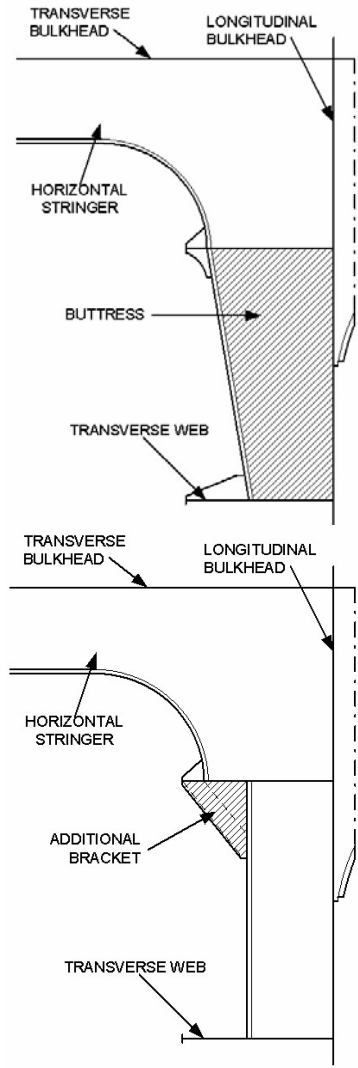
<b>Factors which may have caused damage</b>	<b>Notes on repairs</b>		
<ol style="list-style-type: none"> <li>1. Stress concentration due to discontinuous structure.</li> <li>2. High shear stress in the horizontal stringer.</li> </ol>	See Sketch.

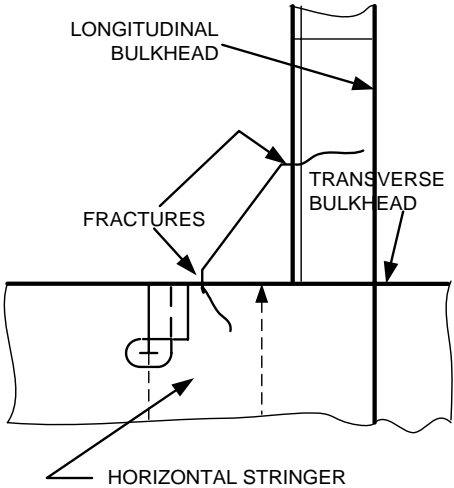
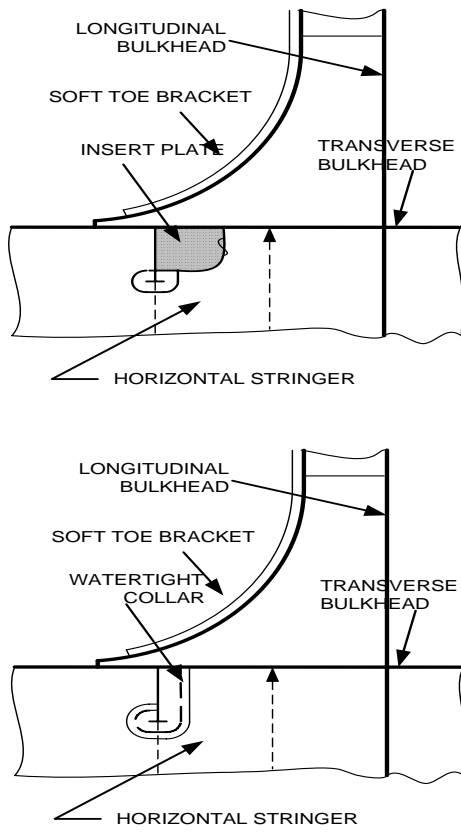
<p><b>Factors which may have caused damage</b></p> <ol style="list-style-type: none"> <li>1. Stress concentration due to inadequate shape of the bracket.</li> <li>2. Relative deflection of adjoining transverse web against transverse bulkhead.</li> </ol>		<p><b>Notes on repairs</b></p> <p>See Sketch</p>

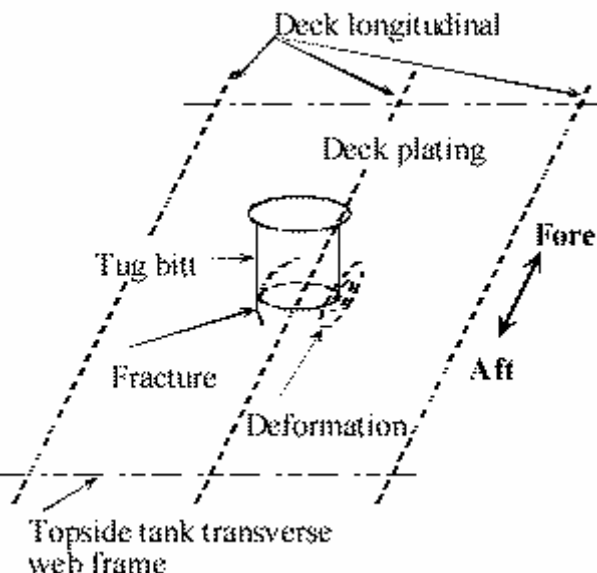
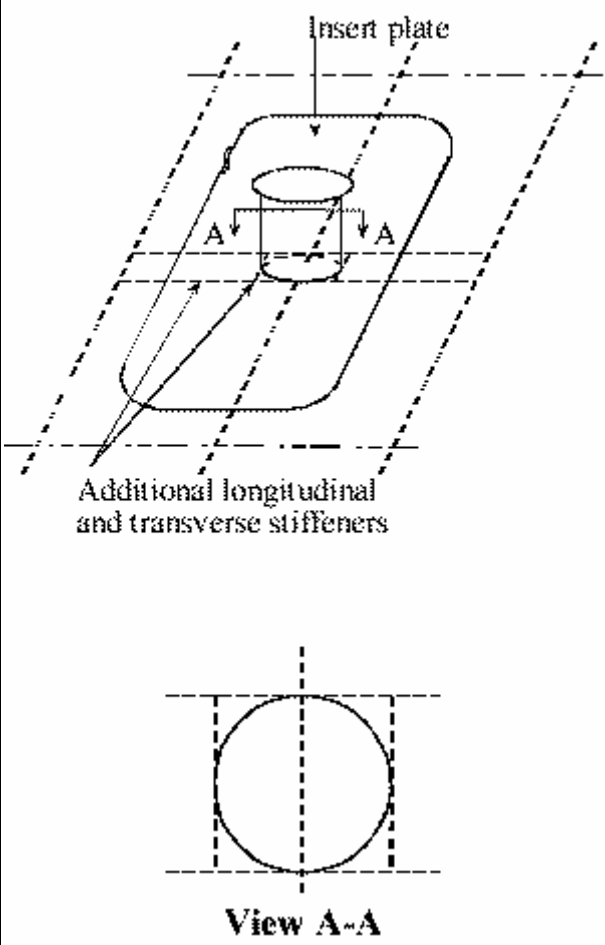
<b>Factors which may have caused damage</b>	<b>Notes on repairs</b>	
<p>1. Insufficient strength</p>	<p>1. Fractured/deformed deck plating should be cropped and part renewed.</p> <p>2. Reinforcement by stiffeners should be considered.</p>

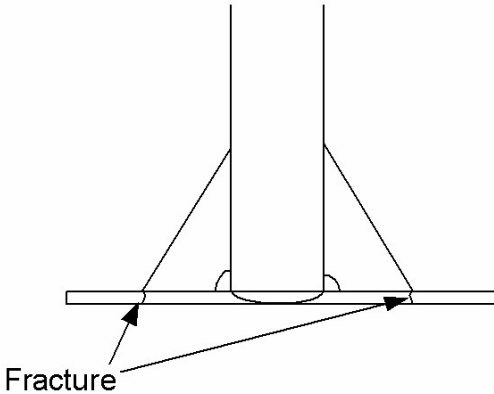
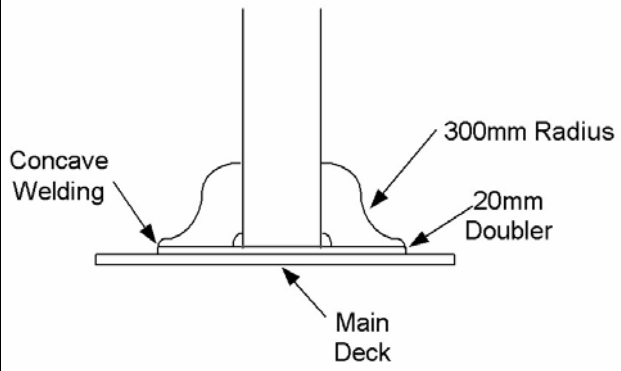
<p>Concave Welding</p> <p>300mm Radius</p> <p>20mm Doubler</p> <p>Main Deck</p>		
<b>Factors which may have caused damage</b>	<p>1. Stanchions experience more severe relative displacements from hull girder bending.</p>		
<b>Notes on repairs</b>	<p>See Sketch.</p>

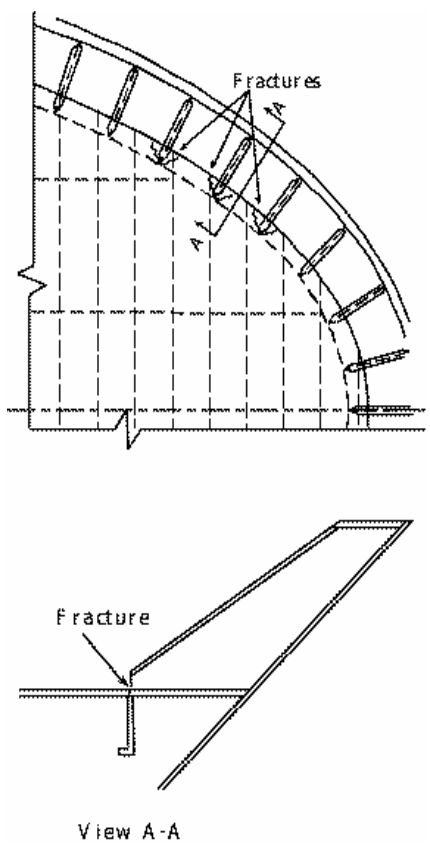
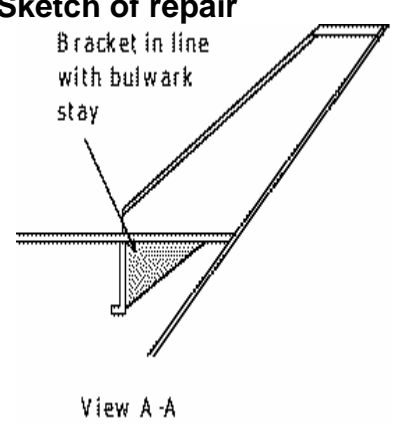
<b>Factors which may have caused damage</b>		<b>Notes on repairs</b>	
<ol style="list-style-type: none"> <li>1. Bow Flare effect in heavy weather.</li> <li>2. Stress concentration due to poor design.</li> </ol>		<ol style="list-style-type: none"> <li>1. Fractured deck plating should be cropped and renewed.</li> <li>2. Bracket in line with the bulwark stay to be fitted to reduce stress concentration.</li> </ol>

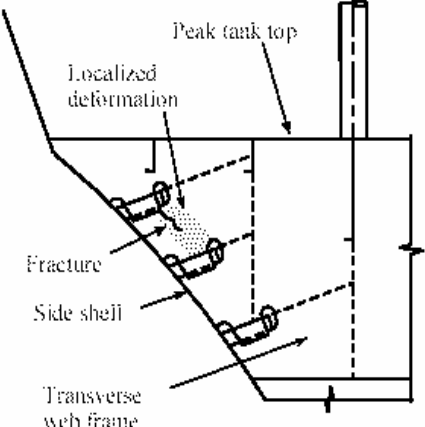
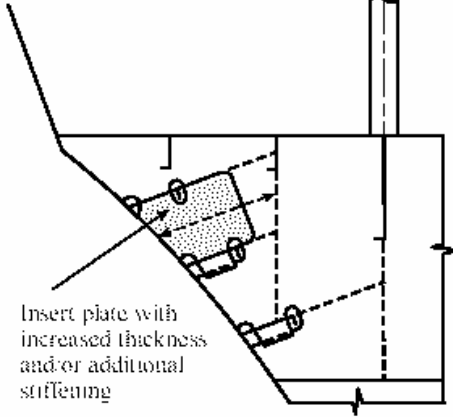
<p>Label in sketch: Insert plate with increased thickness and/or additional stiffening.</p>	
<b>Factors which may have caused damage</b>		<b>Notes on repairs</b>	
<ol style="list-style-type: none"> <li>1. Localized material wastage in way of coating failure at cut-outs and sharp edges due to working of the structure.</li> <li>2. Dynamic seaway loading in way of bow flare.</li> </ol>		<ol style="list-style-type: none"> <li>1. Sufficient panel strength to be provided to absorb the dynamic loads enhanced by bow flare shape.</li> </ol>

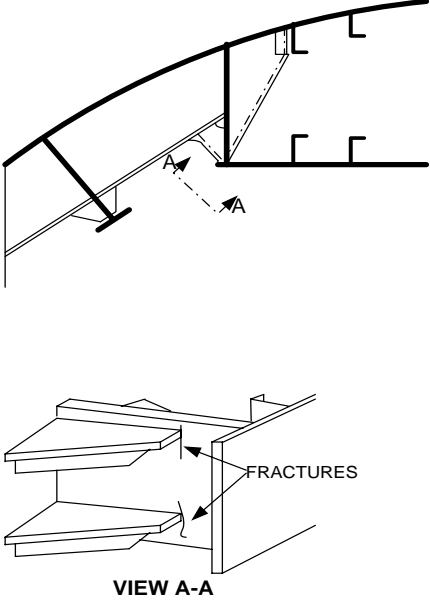
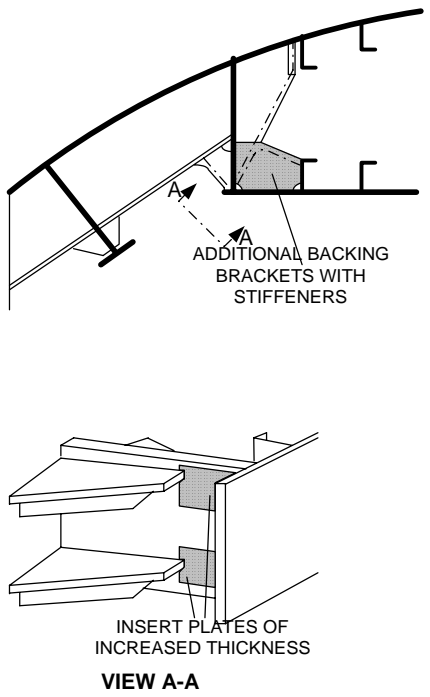
<b>Factors which may have caused damage</b>		<b>Notes on repairs</b>	
<ol style="list-style-type: none"> <li>1. Stress concentrations at bracket ending due to inadequate support at bracket toes in way of connection to web frame members.</li> <li>2. Localised thinning in way of coating failure at bracket endings due to flexing of the structure.</li> <li>3. Dynamic seaway loadings at bow causing flexing at bracket endings.</li> </ol>		<p>See Sketch.</p>

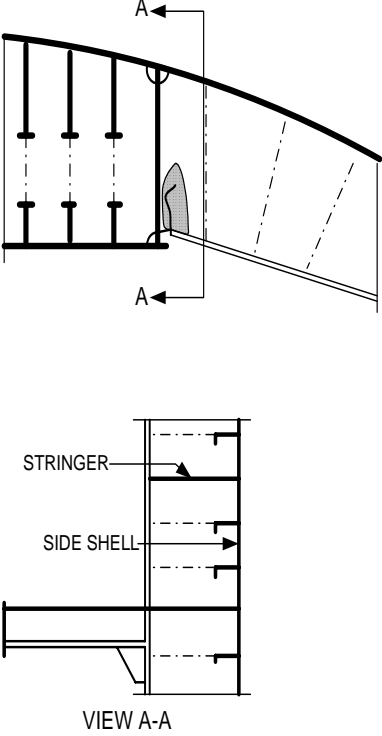
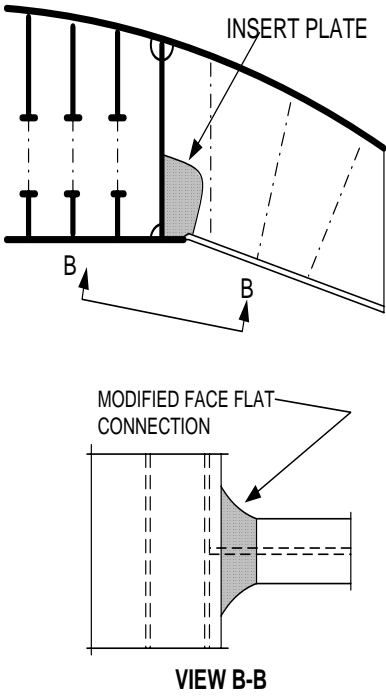
<b>Factors which may have caused damage</b>		<b>Notes on repairs</b>	
<ol style="list-style-type: none"> <li>1. High stress concentration of stringer to stiff girder/deep web intersection due to discontinuity of faceplate.</li> <li>2. Localised thinning in way of coating failure at stringer connection due to flexing of the structure.</li> <li>3. Dynamic seaway loadings at bow causing flexing in way of detail.</li> </ol>		<p>See Sketch.</p>

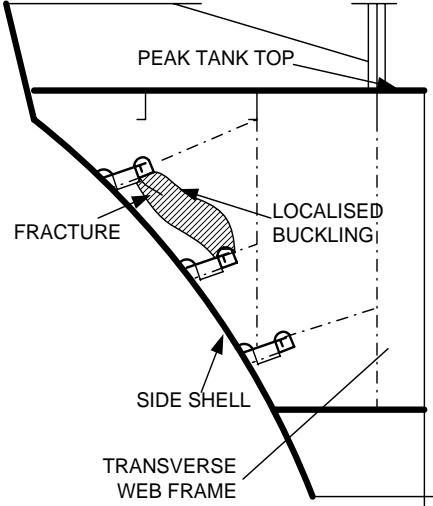
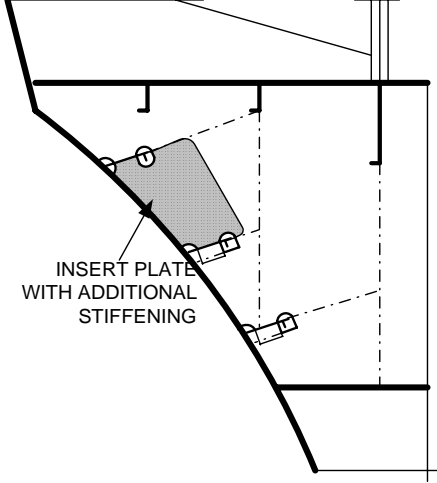
<b>Factors which may have caused damage</b>		<b>Notes on repairs</b>	
<ol style="list-style-type: none"> <li>1. Localised thinning in way of coating failure at cut-outs and sharp edges due to working of the structure.</li> <li>2. Dynamic seaway loadings in way of bow flare.</li> </ol>		See Sketch.

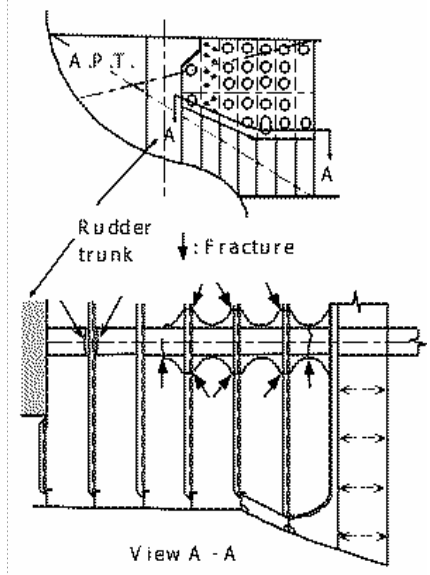
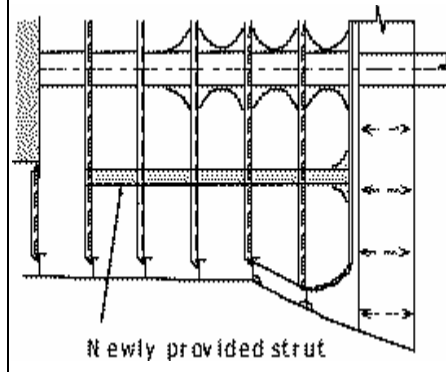
<p>Newly provided strut</p>	
<b>Factors which may have caused damage</b>		<b>Notes on repairs</b>	
<ol style="list-style-type: none"> <li>1. Vibration.</li> </ol>		<ol style="list-style-type: none"> <li>1. The fractured plating should be cropped and renewed.</li> <li>2. Natural frequency of the panel should be changed, e.g. reinforcement by additional strut.</li> </ol>

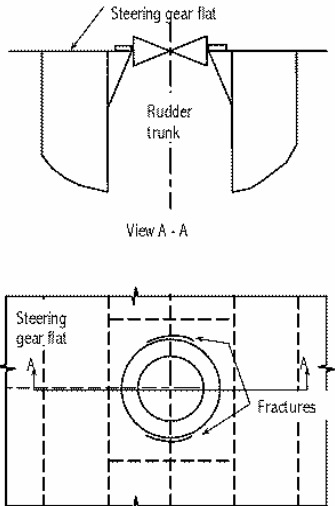
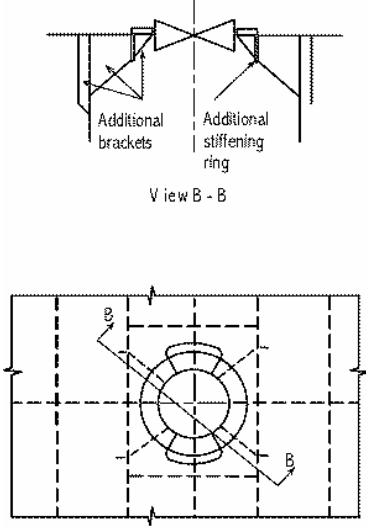
<p>View B - B</p>	
<p><b>Factors which may have caused damage</b></p> <ol style="list-style-type: none"> <li>Inadequate design.</li> </ol>		<p><b>Notes on repairs</b></p> <ol style="list-style-type: none"> <li>Fractured plating should be cropped and renewed.</li> <li>Additional brackets and stiffening ring should be fitted for reinforcement.</li> </ol>

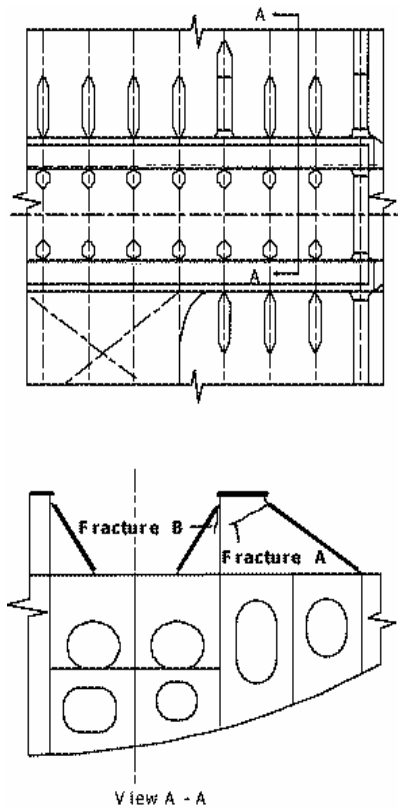
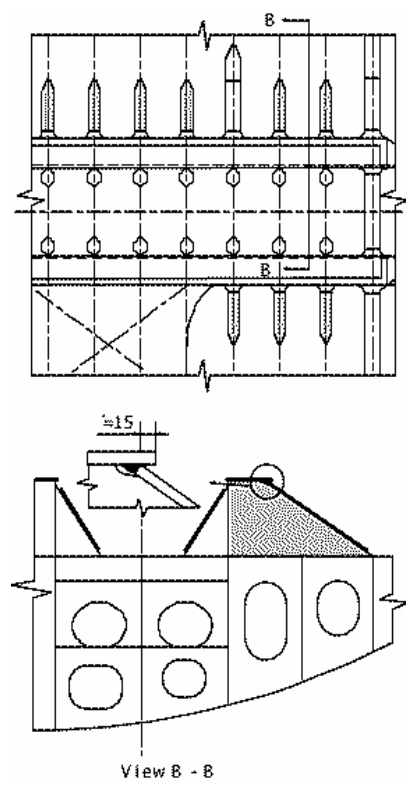
<p><b>Factors which may have caused damage</b></p> <ol style="list-style-type: none"> <li>1. Vibration of main engine.</li> <li>2. Insufficient strength of brackets at main engine foundation.</li> <li>3. Insufficient pre-load of the bolts.</li> </ol>		<p><b>Notes on repairs</b></p> <ol style="list-style-type: none"> <li>1. Fractures may be veed-out and rewelded.</li> <li>2. New modified brackets at main engine foundation.</li> <li>3. Or insert pieces and additional flanges to increase section modulus of the brackets.</li> </ol>

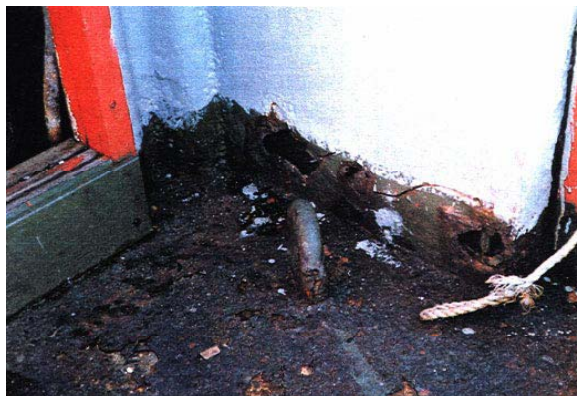
**Photograph 1 Corroded accommodation house side structure**
