# Condition Assessment Programme (CAP)

An introduction to CAP Hull

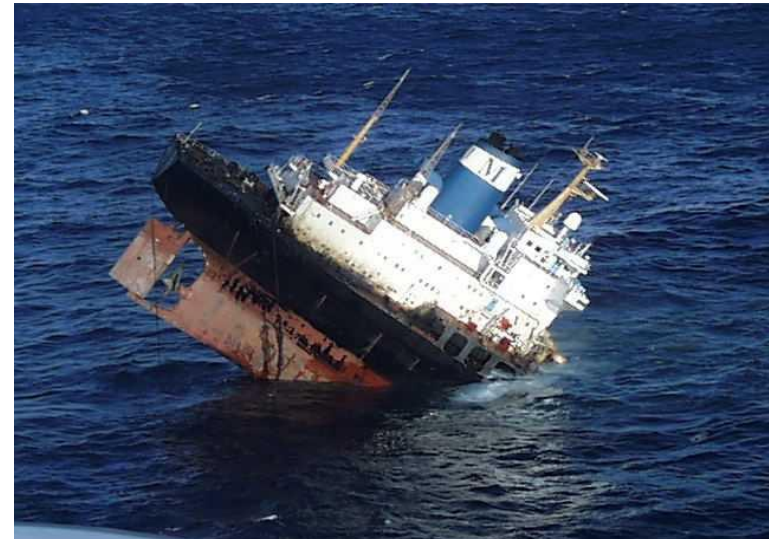
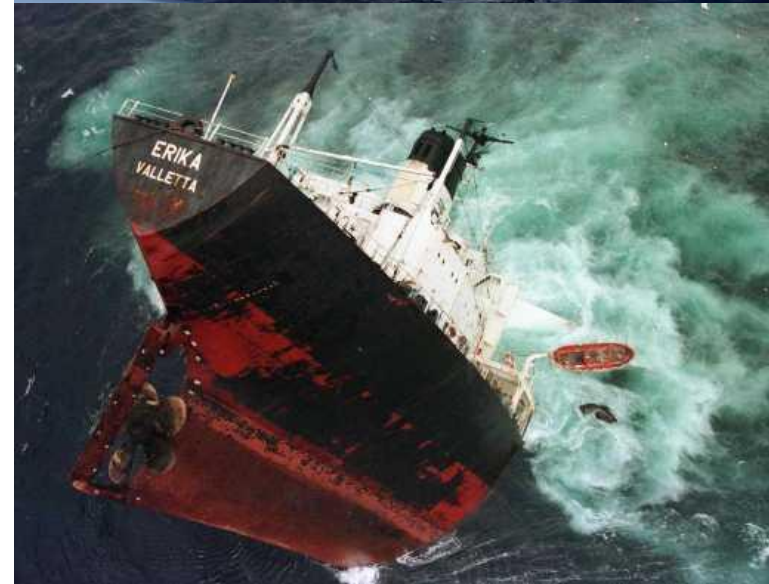
# Erika / Prestige

- Oil tanker accidents in European waters in 1999 / 2001 causing major pollution
- Initial political reflex: Ban single hull tankers from European waters.
- EU pressure on IMO by threats of unilateral action
- Accelerated phase-out of single skin tankers and introduction of CAS
- CAP as a commercial requirement
- A paradigm shift within the shipping industry

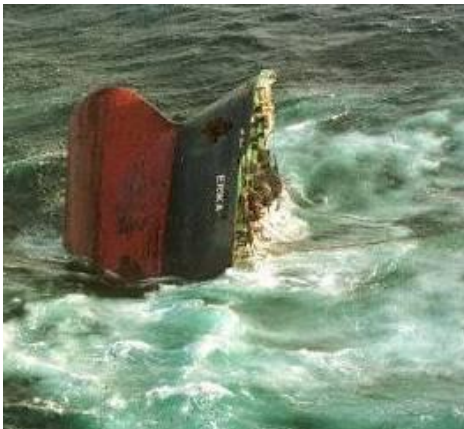
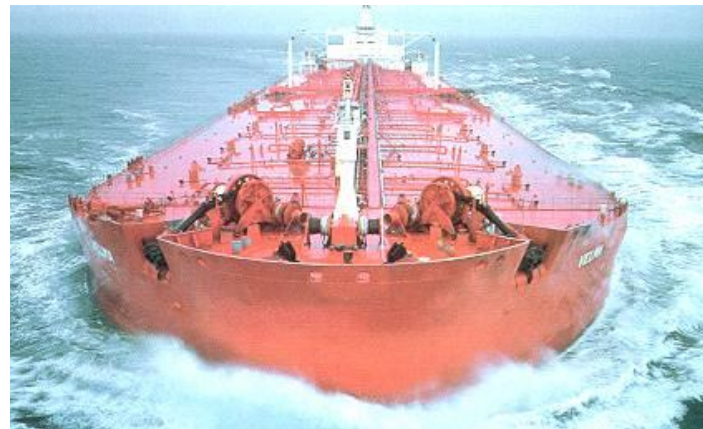
A Need from Shipowners operating well maintained and sometimes extensively modernised older vessels

- To have the technical standard of their vessels more specifically verified and documented
- The vessels to be judged based on the actual condition rather than their age alone

Avoid that these two vessels are treated equally

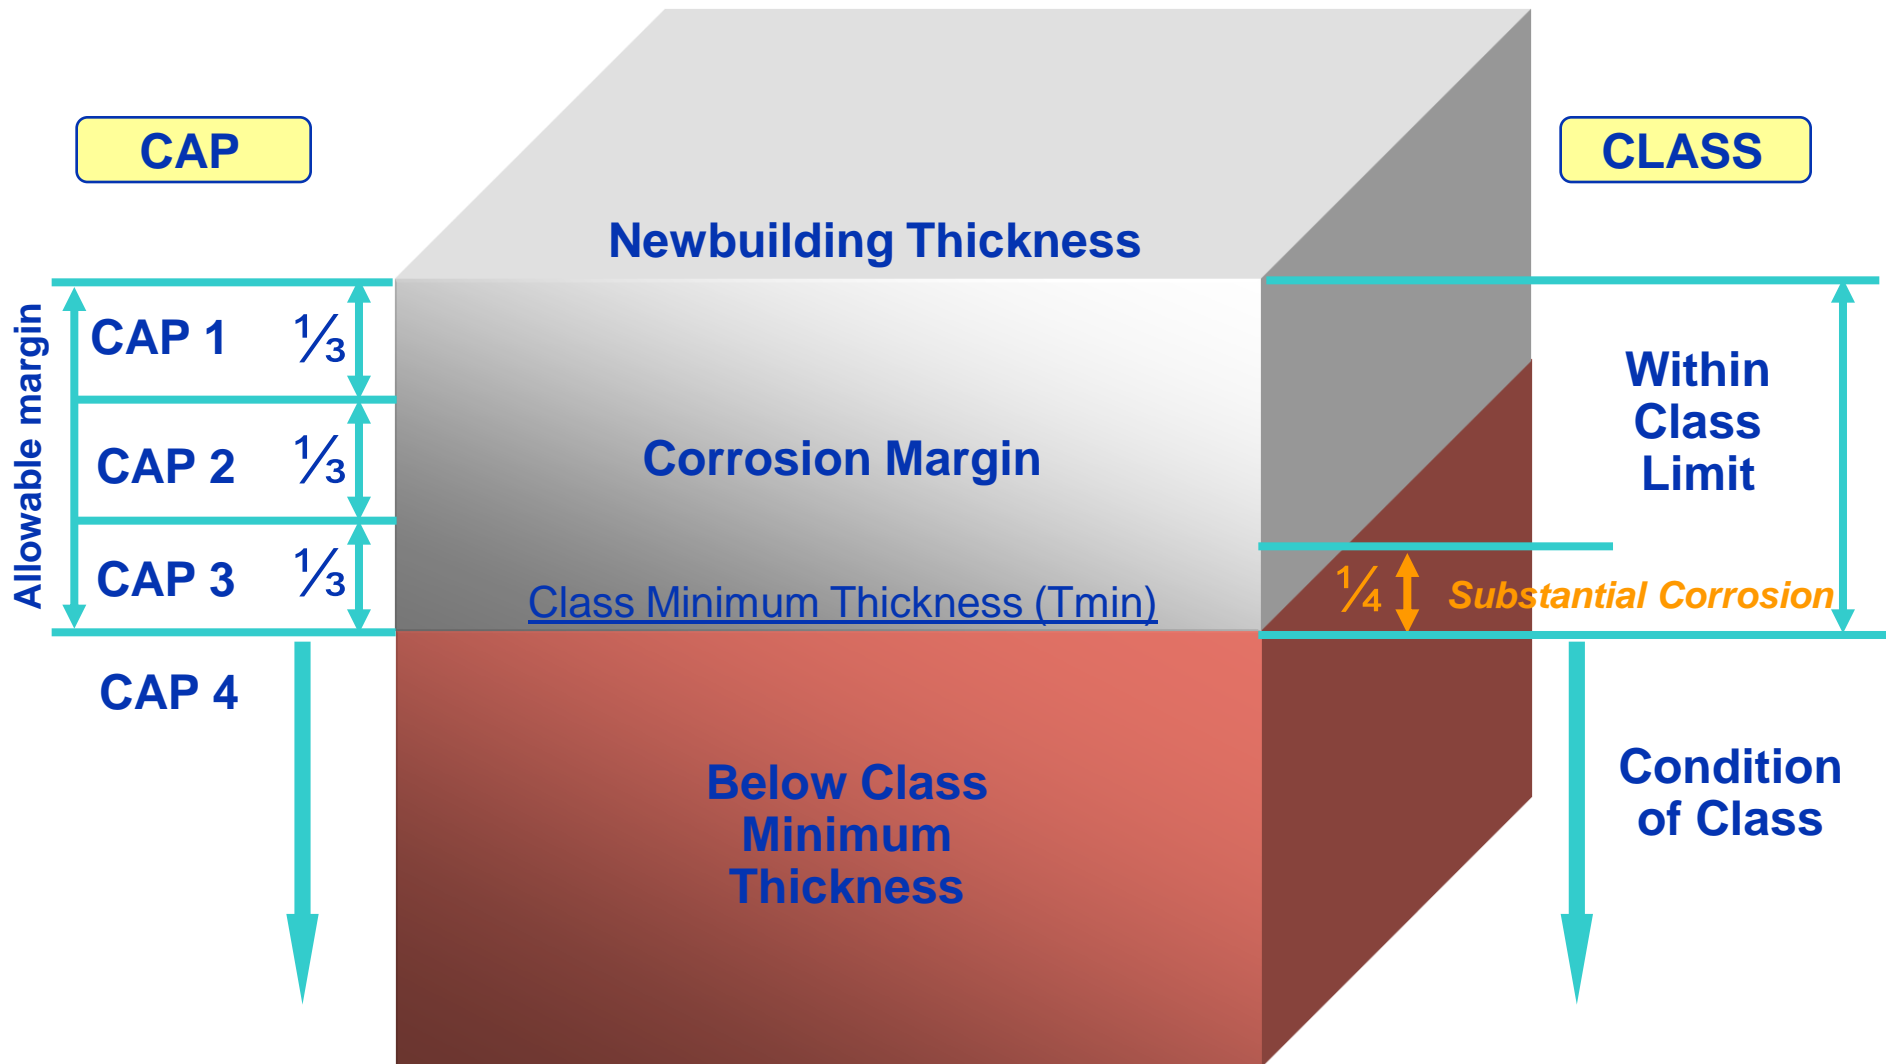
# Rating principle

- The rating of each main structural element is based on the following input:
  - **Visual inspection** to establish extent of local corrosion and defects, and to give a visual impression of the overall condition.
  - Analysis of thickness measurements (**UTM**) to establish extent of general corrosion.
  - Extent and condition of **coating** for segregated ballast tanks.

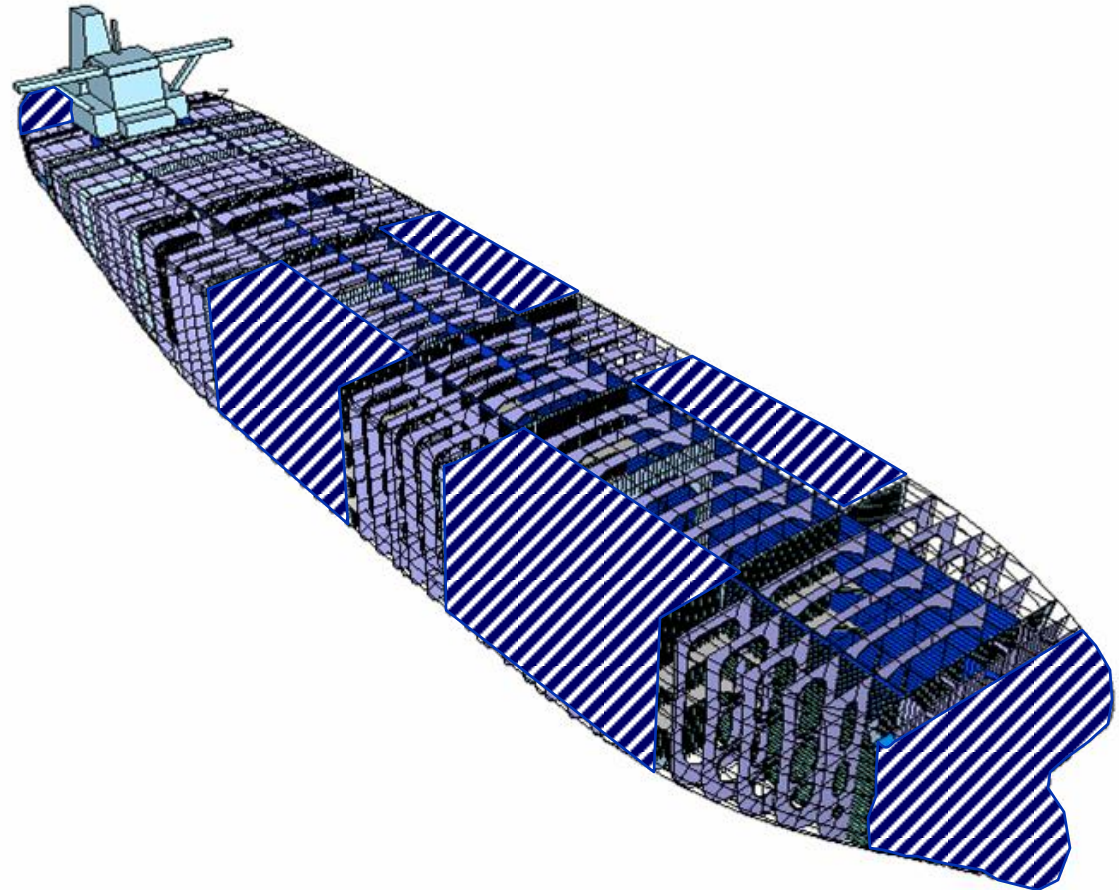
# Ballast tanks

- UTM
- Visual condition
- Coating

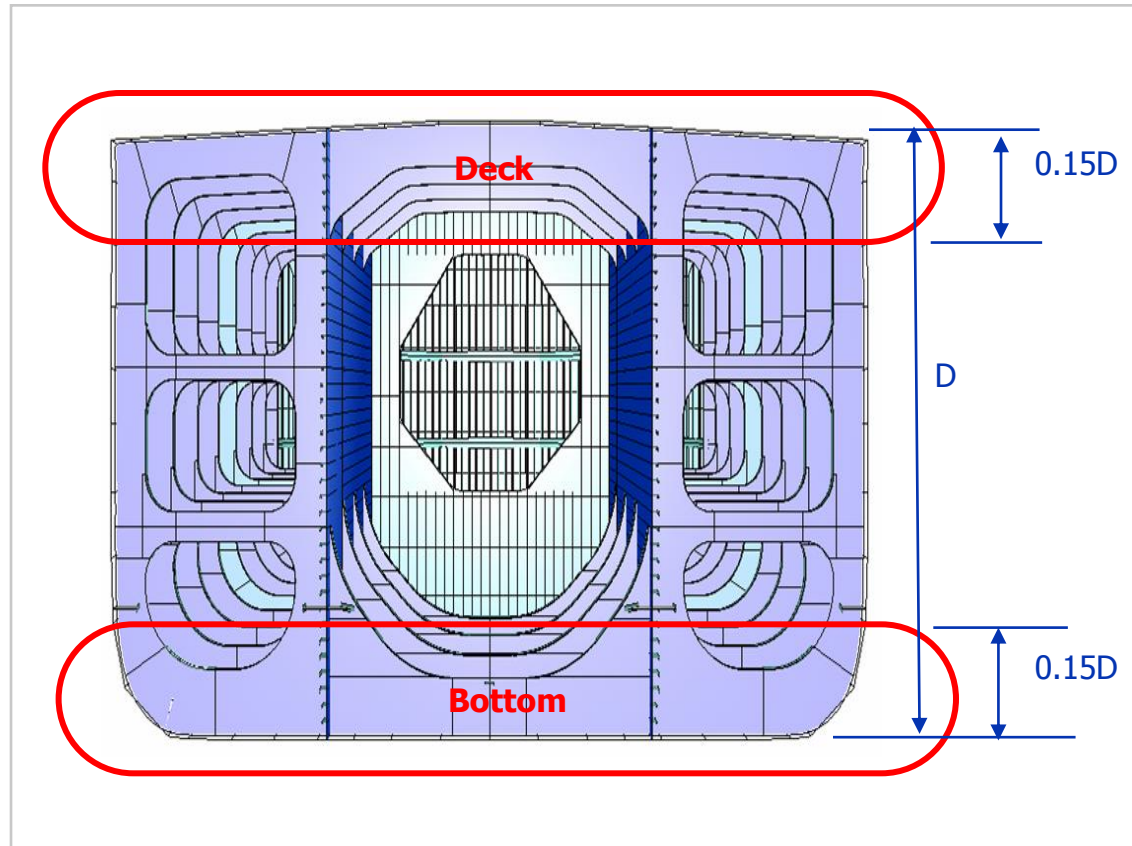
- Section Modulus
- Buckling Capacity of Deck and Bottom Panels

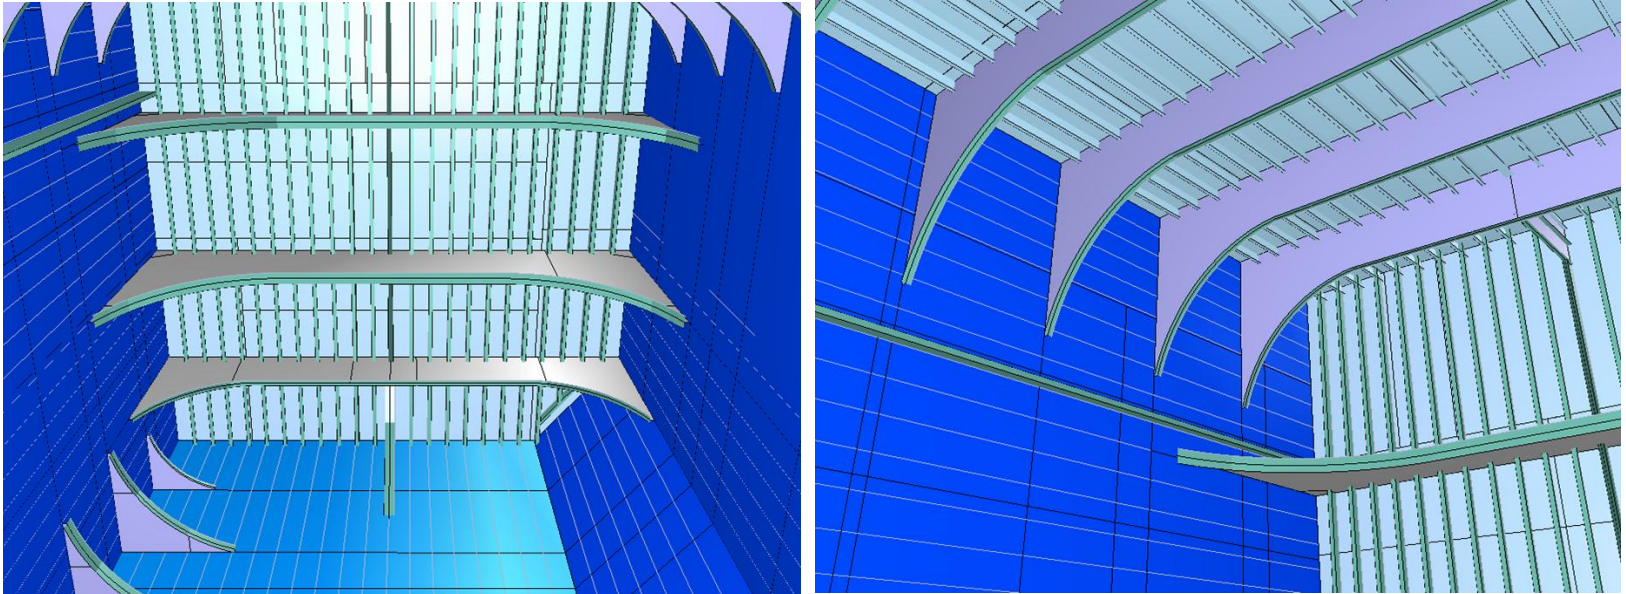
Buckling capacity is calculated using DNV's program PULS (Panel Ultimate Limit State)

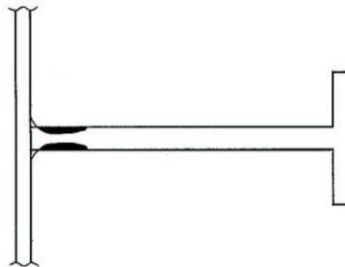
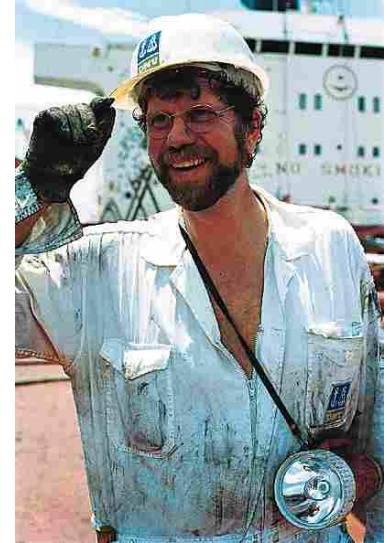
# Visual condition rating

- Visual
  - Edge corrosion, incl. openings
  - Grooving
  - Pitting
  - Indents
  - Any other local defect (e.g. Crack, buckling)
- UTM
- Coating

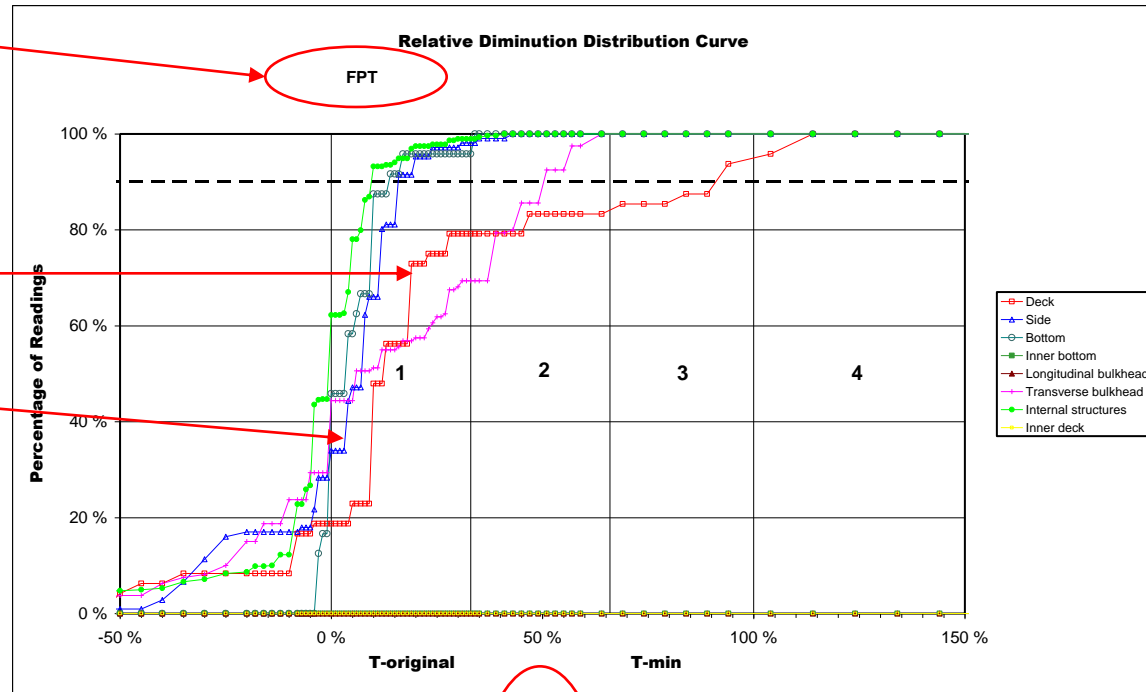
# UTM based rating

For every Tank/Space :

Distribution curves for all Main Structural Elements:

- Deck
- Side
- Bottom
- Inner bottom
- Inner deck
- Longitudinal bulkhead
- Transverse bulkhead
- Internal structures

Main structural element	<i>UTM</i>	<i>Visual</i>	<i>Coating</i>	<i>Overall</i>
Deckhead	3	2	2	2,3
Side	1	1	1	1,0
Bottom	1	1	1	1,0
Transverse bulkhead	2	2	2	2,0
Internal structure	1	2	2	1,7
Tank average rating				1,6
<b>Tank overall rating</b>				<b>2</b>

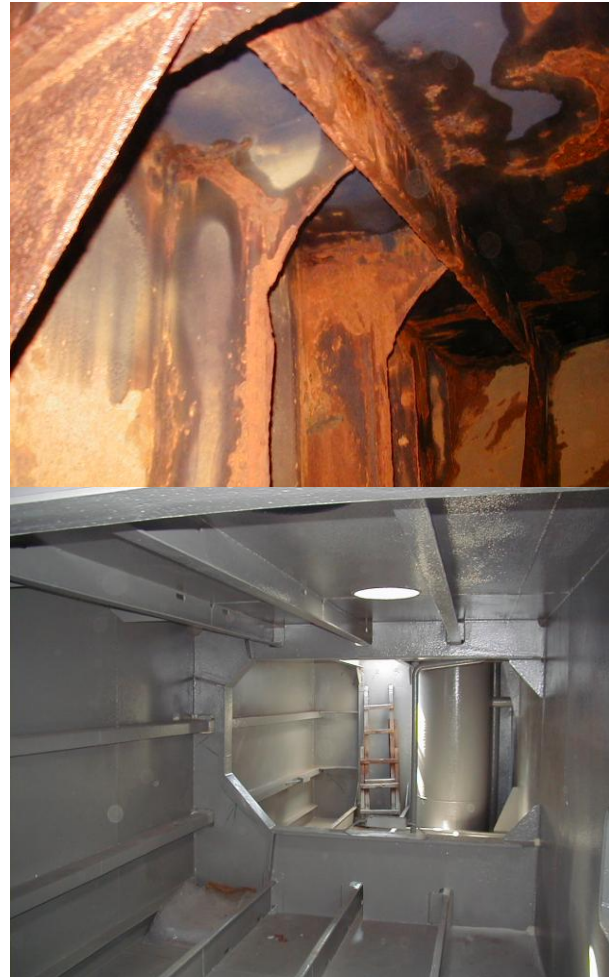
- Visual
  - Edge corrosion, incl. openings
  - Grooving
  - Pitting
  - Indents
  - Any other local defect (e.g. Crack, buckling)
- UTM
- Coating

**Coating rating only for  
Ballast Tanks**

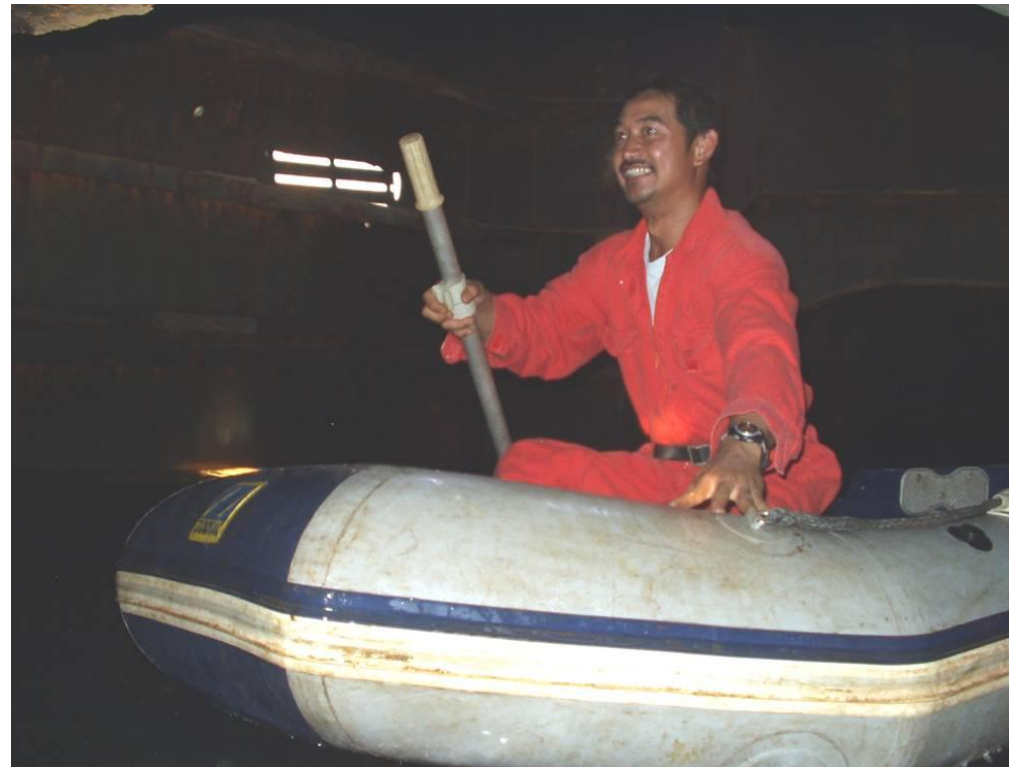
- Rafts or boats alone may be allowed for survey of the under deck areas within tanks if the depth of the webs is 1.5 m or less
- The revised IACS UR are harmonized with the requirements applicable for Condition Assessment Scheme (CAS)

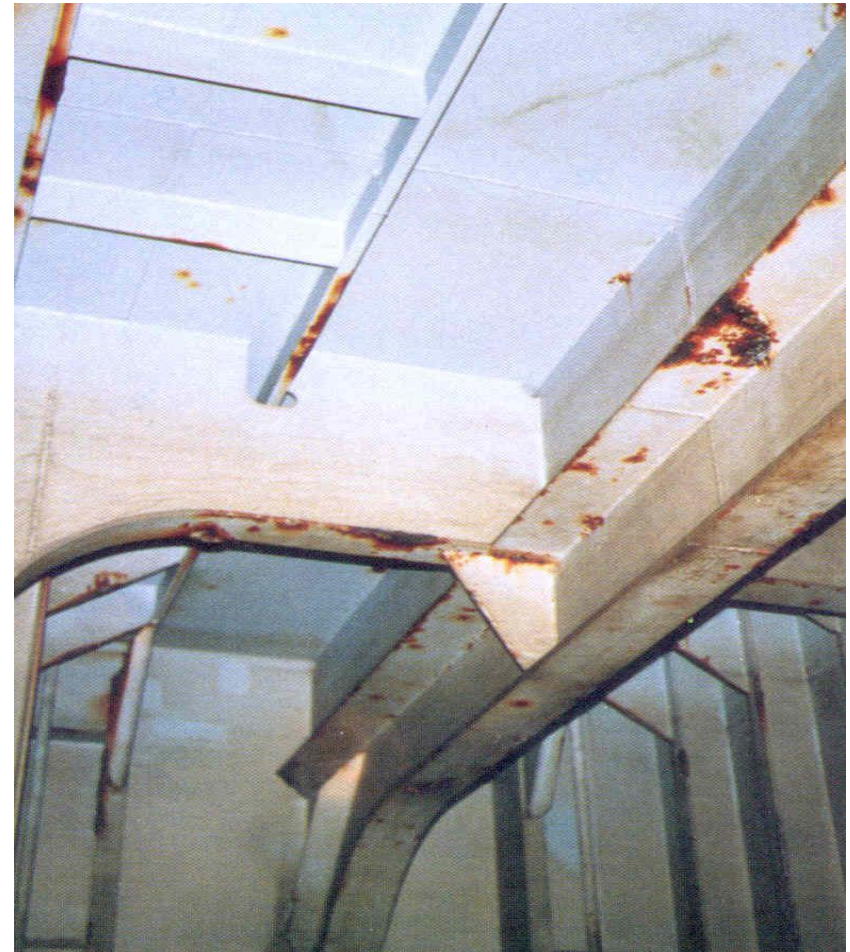
If the depth of the webs is more than 1.5 m, rafts alone may be allowed if:

- The coating of under deck structure is in **GOOD** condition and there is no evidence of wastage.
- An escape route through the air space is provided.

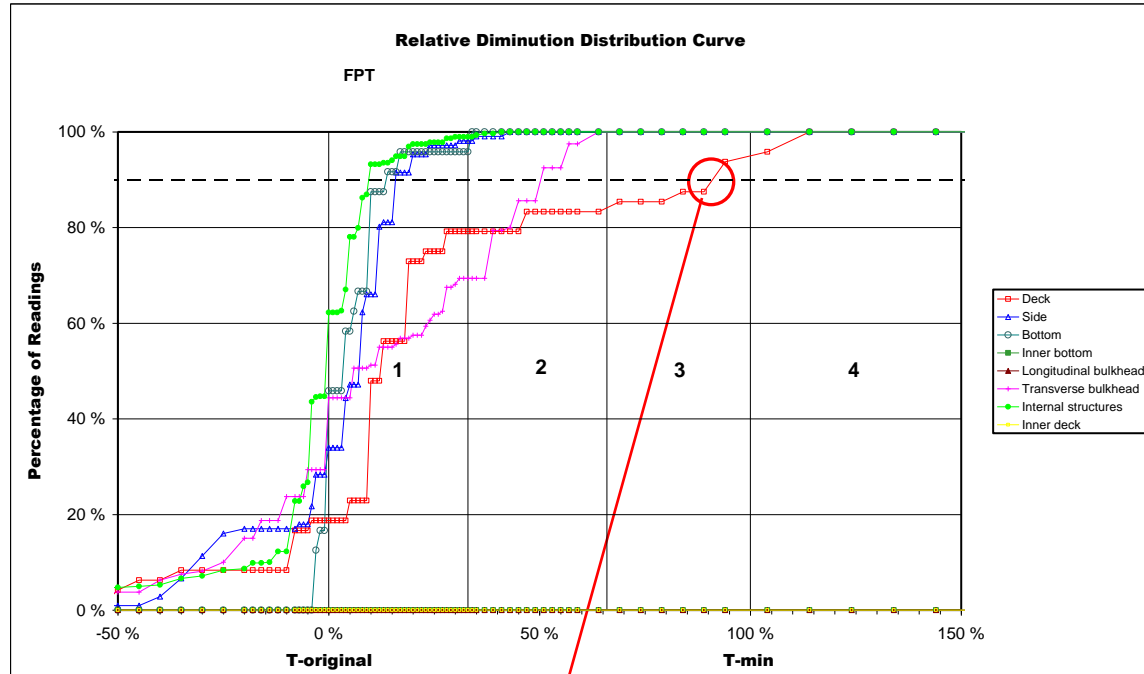
- Initial UTM analysis
- and rating for FPT

Main structural element	UTM	Visual	Coating	Overall
Deckhead	3	2	2	2,3
Side	1	1	1	1,0
Bottom	1	1	1	1,0
Transverse bulkhead	2	2	2	2,0
Internal structure	1	2	2	1,7
Tank average rating				1,6
<b>Tank overall rating</b>				<b>2</b>

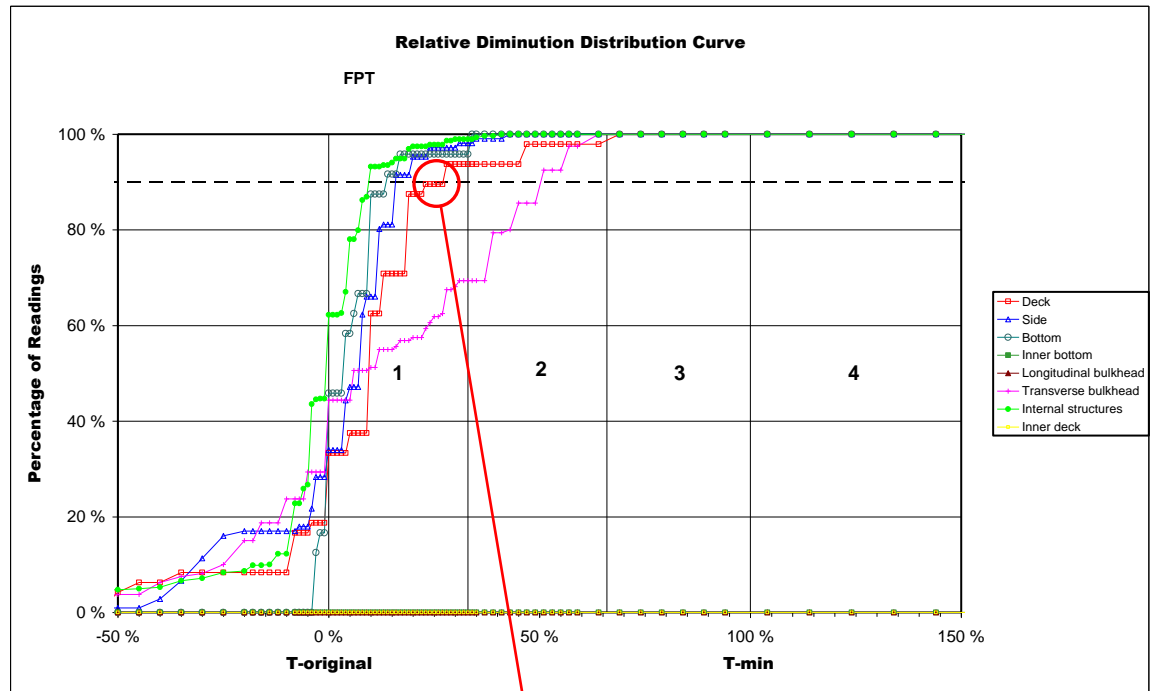
- Updated UTM analysis
- and rating for FPT

Main structural element	<i>UTM</i>	<i>Visual</i>	<i>Coating</i>	<i>Overall</i>
Deckhead	1	2	2	1,7
Side	1	1	1	1,0
Bottom	1	1	1	1,0
Transverse bulkhead	2	2	2	2,0
Internal structure	1	2	2	1,7
Tank average rating				1,5
<b>Tank overall rating</b>				<b>1</b>
