**No. 96**      **Double Hull Oil Tankers - Guidelines for Surveys,**  
(April      **Assessment and Repair of Hull Structures**  
2007)

## DOUBLE HULL OIL TANKERS

Guidelines for Surveys, Assessment and Repair  
of Hull Structures

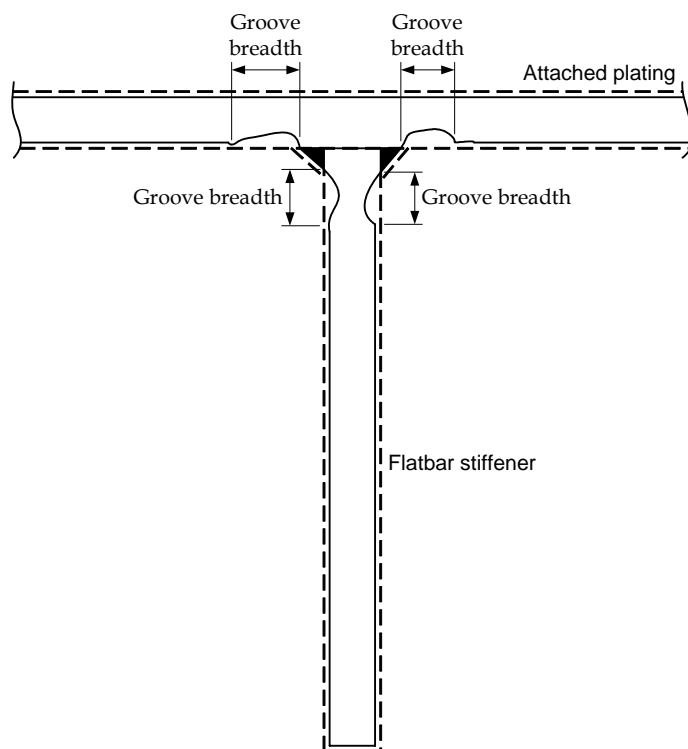
**Figure 8 Grooving Corrosion**

Grooving corrosion is often found in or beside welds, especially in the heat affected zone. This corrosion is sometimes referred to as 'inline pitting attack' and can also occur on vertical members and flush sides of bulkheads in way of flexing. The corrosion is caused by the galvanic current generated from the difference of the metallographic structure between the heat affected zone and base metal. Coating of the welds is generally less effective compared to other areas due to roughness of the surface, which exacerbates the corrosion. Grooving corrosion may lead to stress concentrations and further accelerate the corrosion process. Grooving corrosion may be found in the base material where coating has been scratched or the metal itself has been mechanically damaged. An example of grooving corrosion is shown in Figure 8.

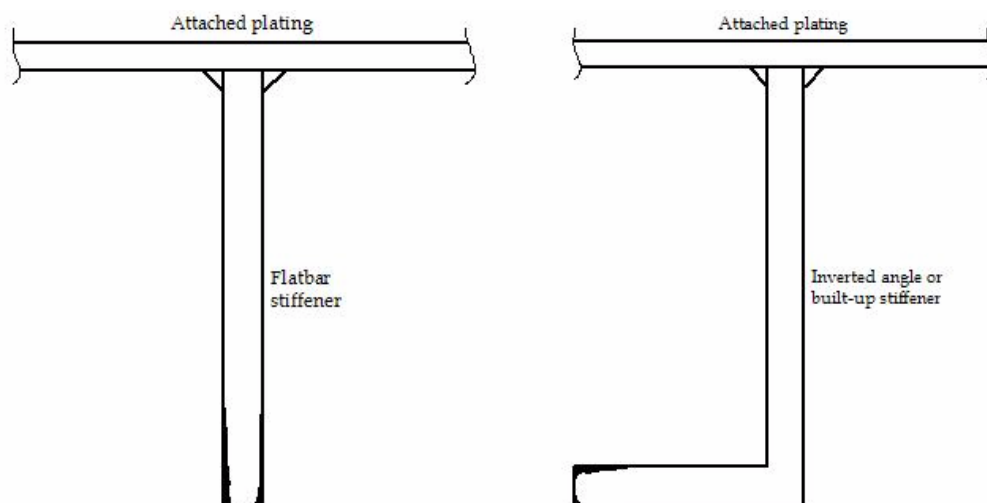
**Figure 9 Edge Corrosion**

Edge corrosion is defined as local corrosion at the free edges of plates, stiffeners, primary support members and around openings. An example of edge corrosion is shown in Figure 9.

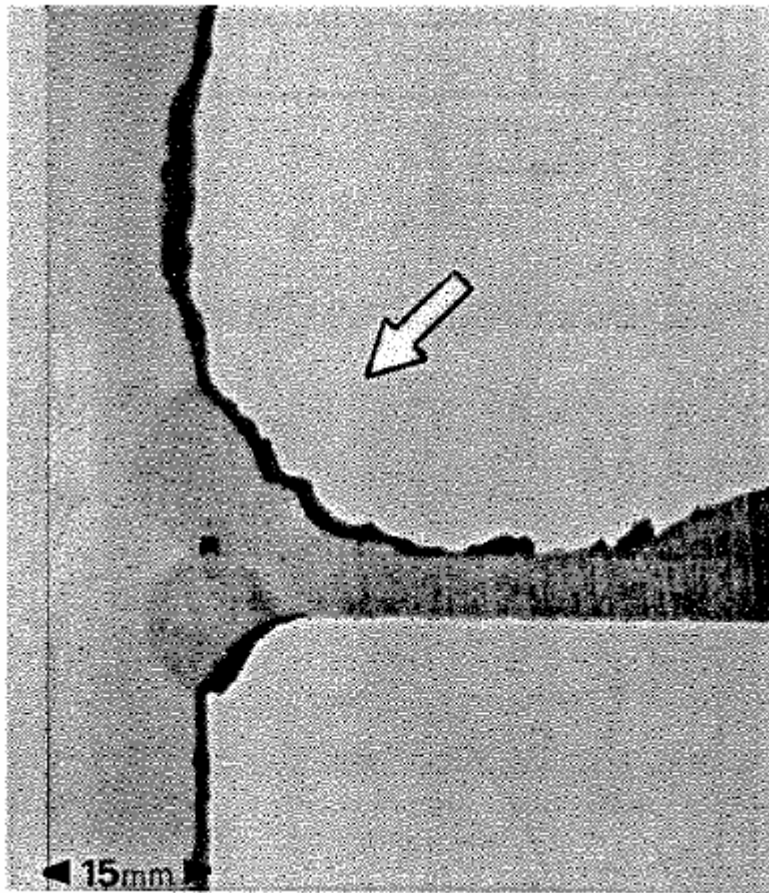
**Figure 10** Detail of Necking Effect

- Necking occurs at the junction of the longitudinal bulkhead plating and longitudinals. The deflection of the bulkhead plating and longitudinals due to reverse, cyclic loading from cargo oil and water ballast plus the accumulated mixtures of water, mud and scale at their junctures accelerates the corrosion rate. As the steel thins and weakens, the flexing consequently increases and hence corrosion accelerates (see Figure 10). The similar necking effect could also occur in the transverse bulkhead plating and stiffeners, or in the inner bottom plating and longitudinals inside the double bottom space. In the coated water ballast tanks, the plating is the principally affected area due to local corrosion in way of coating failure.

One of the best methods of preventing corrosion within these spaces is that protective coatings be applied to the underdeck and inner bottom plating areas. In addition to

protecting the steel structure in these areas, this measure would also enable easier and more effective surveys and surveys to be carried out 'in service'.

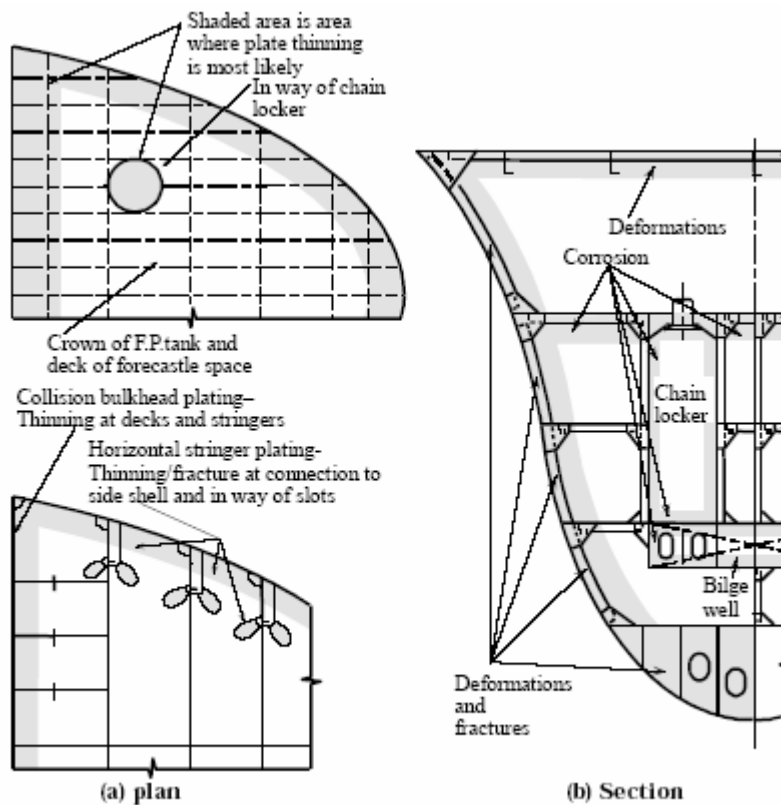
Fig 1 Fore end structure - Potential problem areas

**2.3.2** Fractures are often found in transition region and reference should be made to examples provided in the other Groups.

**2.3.3** Fractures that extend through the thickness of the plating or through the boundary welds may be observed during pressure testing of tanks.

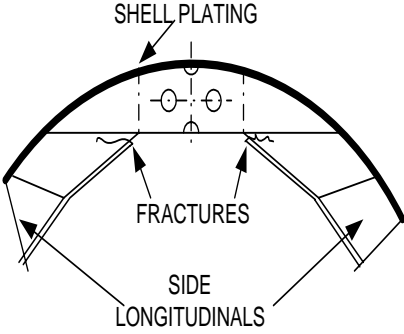
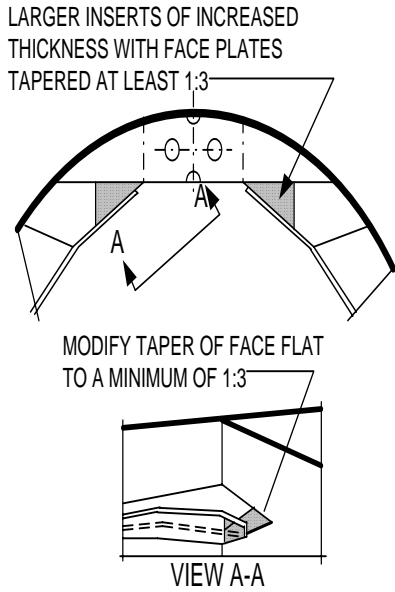
<b>OIL Tankers</b>		<b>Guidelines for Surveys, Assessment and Repair of Hull Structure</b>	
<b>Group 7</b>	<b>Fore region</b>		<b>Example No.</b>
<b>Area 1</b>	<b>Forepeak ballast tank</b>		<b>6</b>
<b>Detail of damage</b>		Fracture at end of longitudinal at bow structure.	
<b>Sketch of damage</b>		<b>Sketch of repair</b>

<b>Factors which may have caused damage</b>		<b>Notes on repairs</b>	
<ol style="list-style-type: none"> <li>1. Inadequate brackets forming the longitudinal endings at bow structure.</li> <li>2. Localised thinning in way of coating failure at longitudinal endings due to flexing of the structure.</li> <li>3. Dynamic seaway loadings at bow causing flexing at longitudinal endings.</li> </ol>		<p>See Sketch.</p>

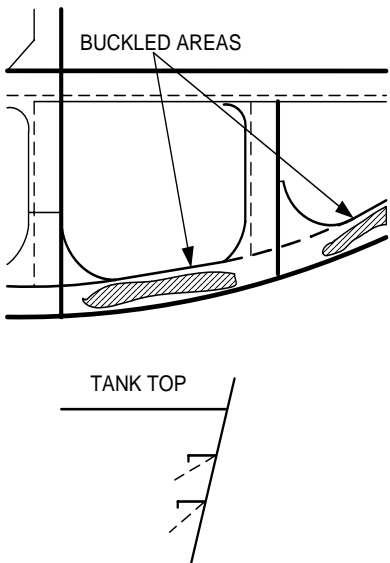
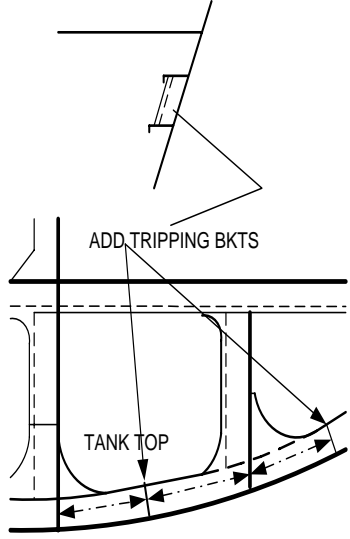
<b>OIL Tankers</b>		<b>Guidelines for Surveys, Assessment and Repair of Hull Structure</b>	
<b>Group 7</b>	<b>Fore region</b>	<b>Example No.</b>	
<b>Area 1</b>	<b>Fore peak ballast tank</b>	<b>8</b>	
<b>Detail of damage</b>		<b>Buckled and tripped breasthooks</b>	
<b>Sketch of damage</b>		<b>Sketch of repair</b>

<b>Factors which may have caused damage</b>		<b>Notes on repairs</b>	
<ol style="list-style-type: none"> <li>1. Bow impact load.</li> <li>2. Low buckling resistance.</li> </ol>		<p>See Sketch.</p>

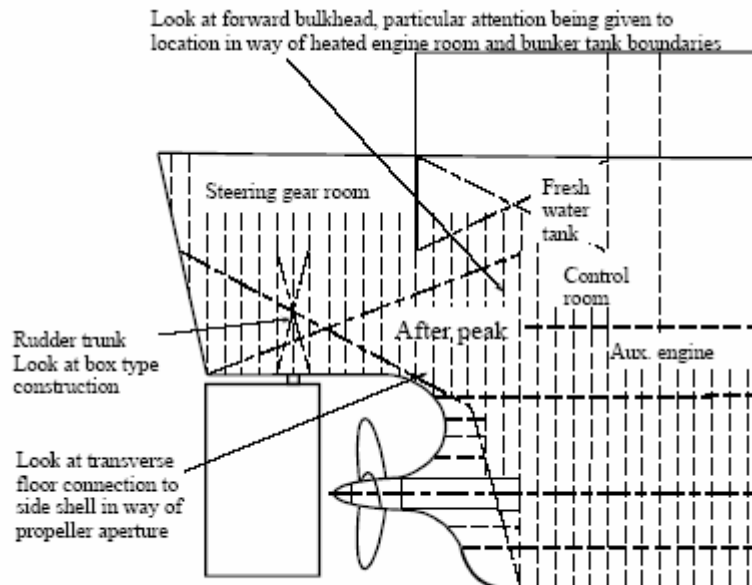
Figure 1 Aft end structure - Potential problem areas

**2.3.1** Fractures in weld at floor connections and other locations in the aft peak tank and rudder trunk space can normally only be found by close-up survey.

**2.3.2** The structure supporting the rudder carrier may fracture and/or deform due to excessive load on the rudder. Bolts connecting the rudder carrier to the steering gear flat may also suffer damage under such load.
